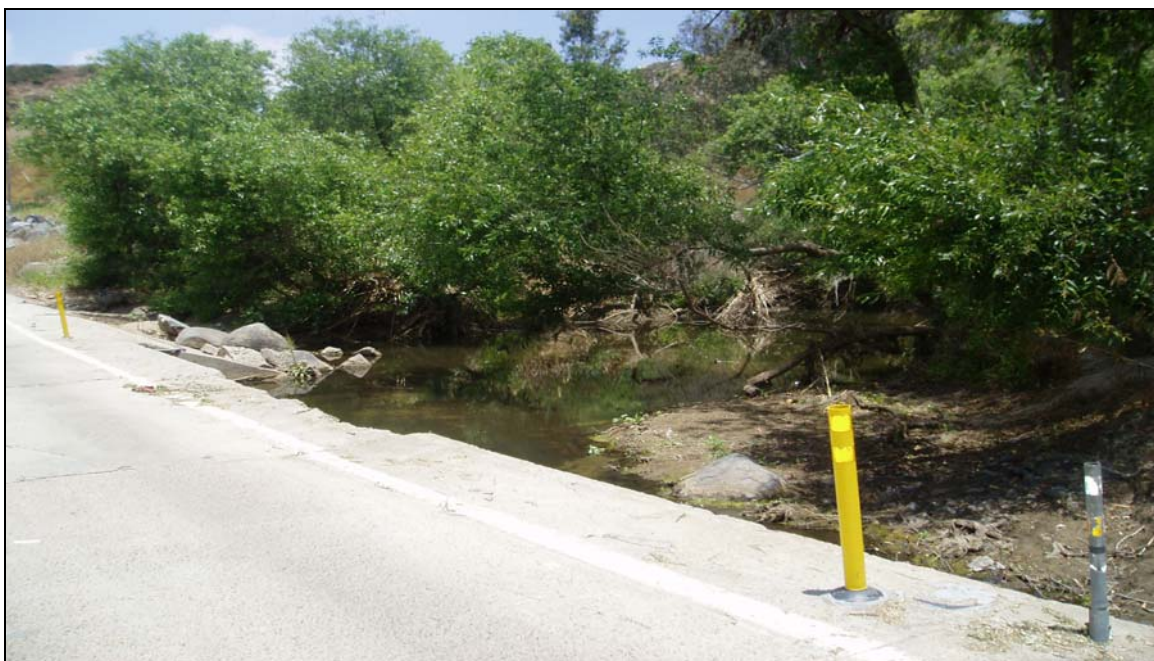
Photo Point 34. Fourth location along Escondido Creek located approximately 0.9 mile down stream from confluence with unnamed tributary. View is upstream from the Country Club Road crossing (16 June 2005).

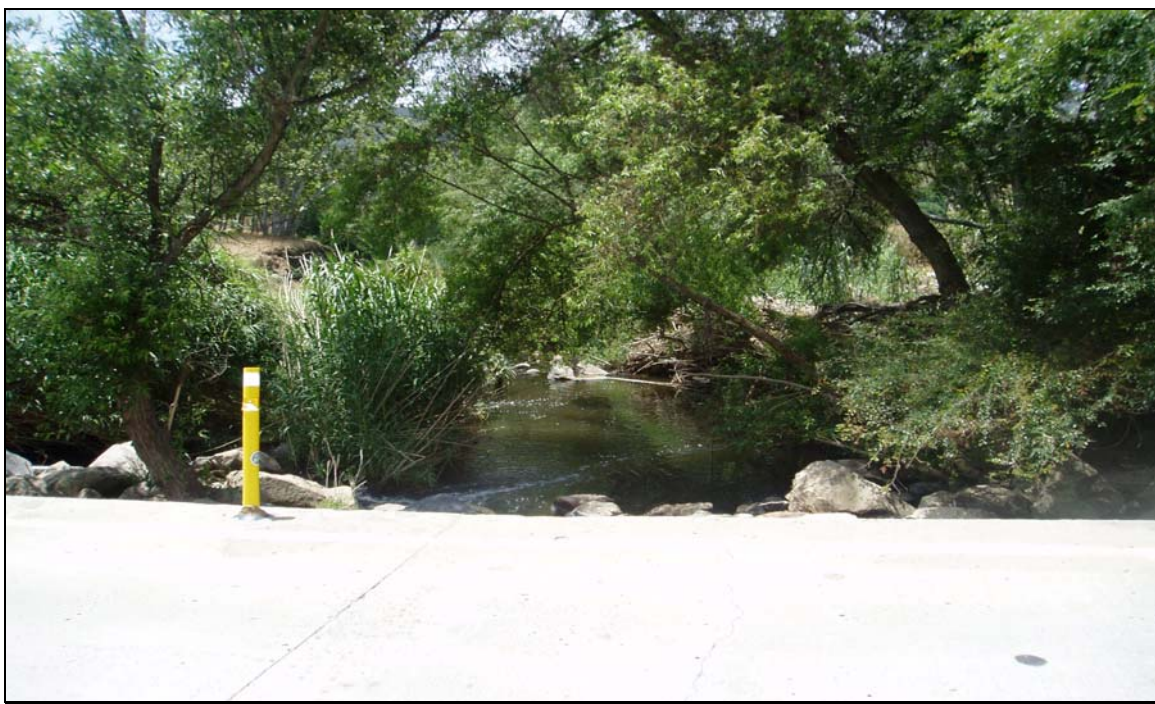
Photo Point 35. Fifth location along Escondido Creek approximately 0.9 mile down stream from the confluence with unnamed tributary. View is downstream from the Country Club Road crossing (16 June 2005).
